Quality Assurance and Source Inspection

Contract #: 04-0120F4Cty: SF/ALA Rte: 80 PM: 13.2/13.9File #: 69.28**WELDING INSPECTION REPORT****Resident Engineer:** Pursell, Gary**Address:** 333 Burma Road**City:** Oakland, CA 94607**Report No:** WIR-000427**Date Inspected:** 25-Aug-2007**Project Name:** SAS Superstructure**OSM Arrival Time:** 630**Prime Contractor:** American Bridge/Fluor Enterprises, a JV**OSM Departure Time:** 1530**Contractor:** Zhenhua Port Machinery Company, Ltd (ZPMC), Changxing Island **Location:** Shanghai, China**CWI Name:** Xu Lefeng**CWI Present:** Yes No**Inspected CWI report:** Yes No N/A**Rod Oven in Use:** Yes No N/A**Electrode to specification:** Yes No N/A**Weld Procedures Followed:** Yes No N/A**Qualified Welders:** Yes No N/A**Verified Joint Fit-up:** Yes No N/A**Approved Drawings:** Yes No N/A**Approved WPS:** Yes No N/A**Delayed / Cancelled:** Yes No N/A**Bridge No:** 34-0006**Component:** N/A**Summary of Items Observed:**

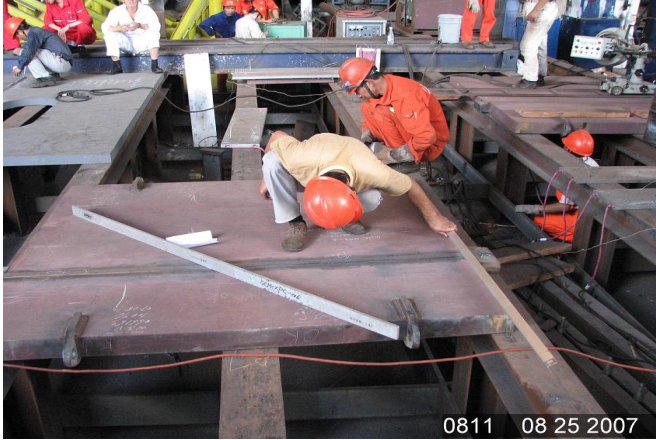
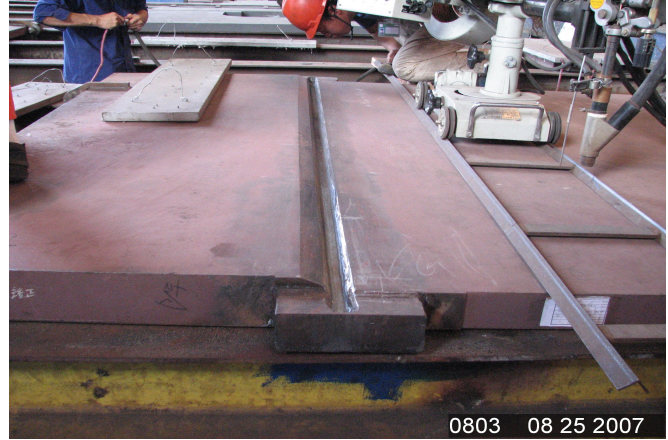
The photos below show ZPMC performing dimensional inspections to the skin panel B and the skin panel E weld splice side # 1 that was being welded on this date.
